A2.3.6 GENERAL CONSERVATION STATE ANALYSIS REPORT

Prepared by: Royal Scientific Society – CSBC

Name of Building: Guests House\ AL-Karak Municipality

Location: AL-Karak governorate – South Jordan

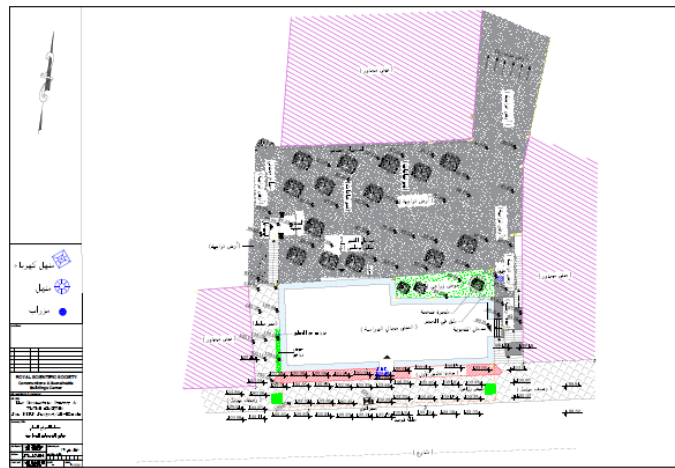
Drawing 3

The general structural condition of the building is good, as no cracks were noticed inside or outside the building with the exception of a crack in the rear outer stone facade at the eastern corner of the building.

See drawing No. 3 (Site Plan).
