A2.3.6 GENERAL CONSERVATION STATE ANALYSIS REPORT

Prepared by: Royal Scientific Society – CSBC

Name of Building: Guests House\ AL-Karak Municipality

Location: AL-Karak governorate – South Jordan

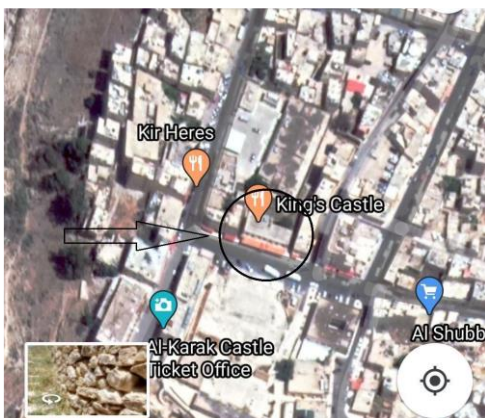
Picture 2

The building is located in AL-Karak Governorate, in the area opposite to AL-Karak Castle. there is a public street from the front façade of the building with a tiled pavement for pedestrian [Pic.2], while there is a nearby building on both sides (western and eastern sides) of the building, and a dirt portion from the back side of the mentioned building, with a staircase leads to the basement in the eastern corridor of the building.
